CLEAN-COAL TECHNOLOGY BY-PRODUCTS USED IN A HIGHWAY
EMBANKMENT STABILIZATION DEMONSTRATION PROJECT

A Thesis

Presented in Partial Fulfillment of the Requirements
for the Degree Master of Sciences in the
Graduate School of The Ohio State University

The Ohio State University
1994

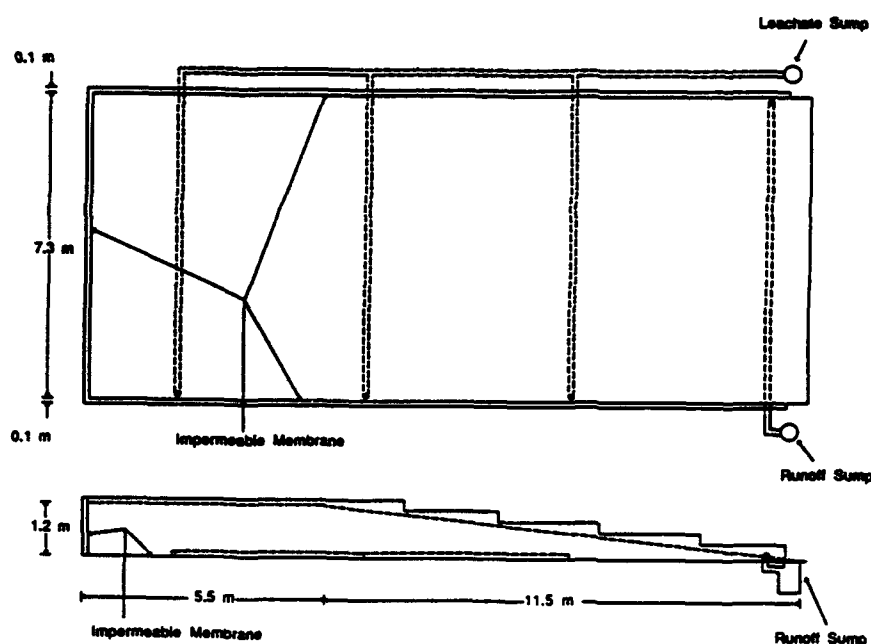
Figure 1.2. OSU FGD By-Product Truck Ramp, Plan and Section View.

Tests performed on samples cored from the ramp over the first ten months after it was placed into service show that although the ash was not saturated, the water content was considerably higher than the optimum water content. The in-place

density was found to range between 0.83 g/cm^3 to 1.06 g/cm^3 . Laboratory strengths obtained from unconfined compression tests performed on the cored field samples varied greatly (76 to 840 kPa) and were noticeably lower than the values achieved on the laboratory compacted samples. These variations in properties emphasize the importance of maintaining proper control over moisture and compaction during construction.

Despite the difficulties in achieving the design conditions during construction, there have been no problems with performance and no evidence of distress. For the sake of brevity, the engineering properties of the OSU FGD by-product and typical engineering properties for soil were excluded, but can be found in Adams et al., 1992. Water samples have been periodically collected from both underdrains

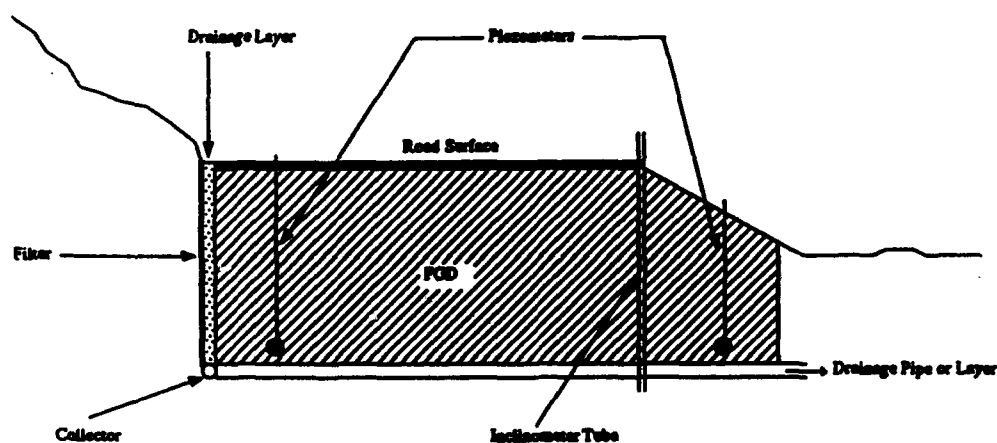
Figure 1.3: SR 83 Cross-Section.

Approximately 300 meters of SR 83 on a hillside in Cumberland, Ohio (Site #3 on Figure 1.1), has been damaged by landslides. This section of roadway has experienced settlements for a number of years, so after repeated patchwork efforts,

it was determined that a more substantial repair project would be undertaken. Surface conditions indicate that the current slide is rotational in nature with a scarp roughly following the centerline of the road. A subsurface investigation of the site was conducted in early September, 1993, by ODOT. Although the full results are not yet available, the base of the slide appears to be approximately 6 meters below the roadway. However, there is ample evidence that the area has experienced multiple slides in the past. This demonstration project calls for the Ohio Department of Transportation (ODOT) to excavate the natural soil above the slide plane and replace that soil with dry FGD by-products from AEP's Tidd plant. A sketch of the intended design for this site is given as Figure 1.3. The measurements made on the Tidd by-product at EORDC clearly show that when compacted, this material reaches a very high strength and would therefore be a suitable material for stabilizing this slide.

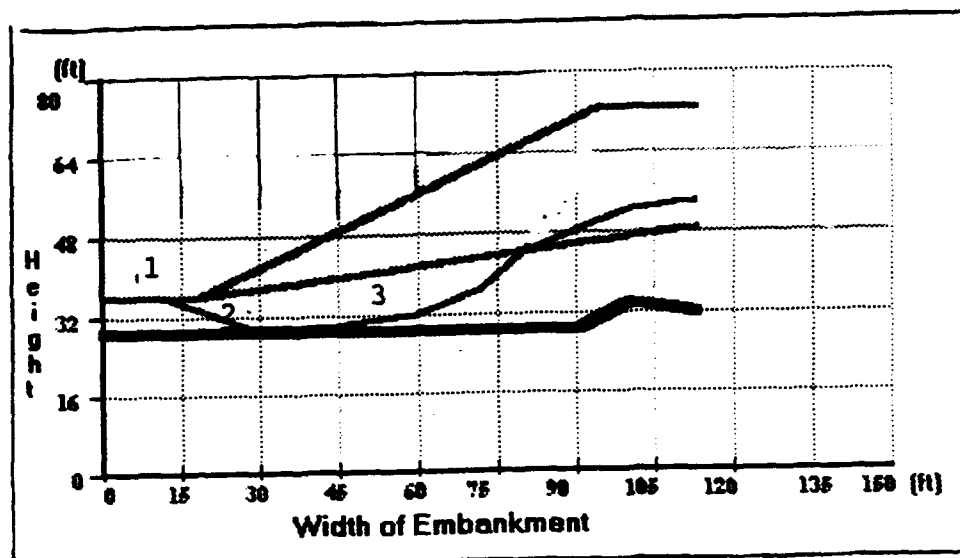
Figure 2.3. SR 541, Typical Section.

The repair crew started the project by flattening out the traverse ridges which had formed at the base of the embankment. As they began to excavate, a layer of moist grayish (olive brown) clayey-shale was exposed (location #1 on Figure 2.3). After a few meters of excavation, the grayish soil being removed was completely saturated. The elevation of the saturated layer seemed to coincide with the elevation of the original natural ground surface beneath the embankment as depicted in the original construction plans (location #2 on Figure 2.3). The weight of the vehicles operating on the soil caused it to pump, temporarily halting the operation while a trench was dug to find the source of the excess water. When the trench was approximately 2 meters deep, a spring was discovered (Figure 2.5).

edge of the highway, had progressed across the road to its southern edge. The bottom of the excavation was approximately 13 meters below the original road surface (location #3 on Figure 2.3). At that elevation, the soil was a combination of exposed shale and a very stiff blue-gray shale clay. The saturated fill material, which had very poor strength properties, continued to fail as the surrounding material was excavated. This led to the propagation of failure that eventually resulted in an excavation effort much larger than originally planned (Figure 2.6).

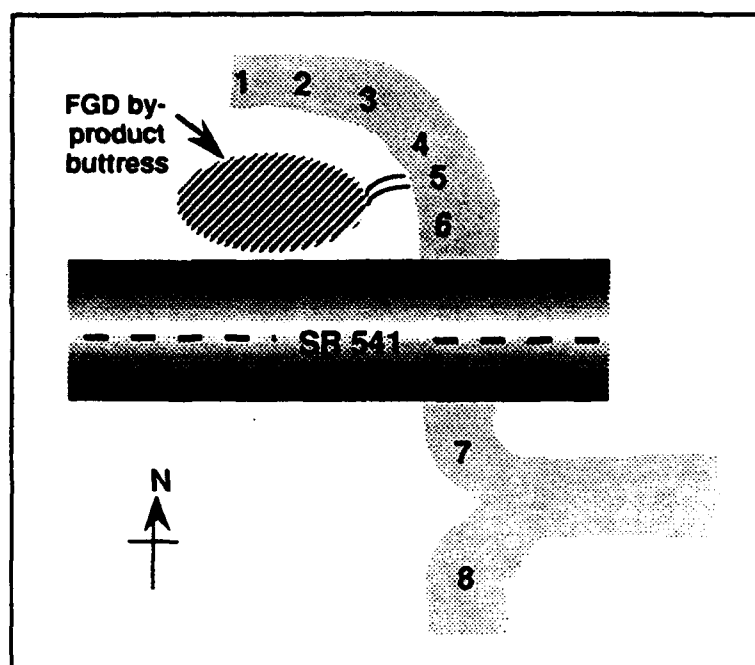
Figure 2.13. SR 541 Embankment, pH Reading Locations Along Stream.

Eight locations were identified and used as reading points. Three of the locations were significantly upstream of the lower drain outlet and were chosen because they should not be affected by any FGD by-product related drainage. These locations may be viewed as points #1, #2, and #3 on Figure 2.13. It is also highly unlikely that these locations are in anyway affected by FGD material influenced runoff, since the top of the FGD buttress is several feet below the slope surface and only a few feet above the stream level. One location was selected in the outlet drain and

directly measured the pH of the water being expelled from the drainage material installed at the base of the lower buttress and can be viewed as point #5 on Figure 2.13. Measurement points were established on either side of the drain, approximately 1 meter upstream and downstream and are points #4 and #6 on Figure 2.13, respectively. Presumably, the eddies caused by the rocks within the stream and the natural terrain of the area caused this region to act as a mixing area. Another measuring point was selected approximately 50 meters downstream to examine the effects of the drainage water on the stream system as a whole, and is seen as point #7 on Figure 2.13. It can be inferred that the water from the drain and the natural stream water were well mixed by this point in the system. Finally, point #8 (Figure 2.13) was selected in an adjacent stream prior to its confluence with the stream of interest. This was done to measure the pH of a stream that was in no way related to the FGD by-product demonstration project and to establish a normal pH fluctuation range. Figure 2.14 shows the stream and one of the reading locations.

No significant differences have been observed in the pre-construction and post-construction values and the differences that have been noted fall within an accepted range of normal stream fluctuations. The stream that runs along the construction area has not experienced fluctuations greater than those measured in the adjacent stream. This is encouraging, as large fluctuations in stream pH would be detrimental towards the future use of this type of material in water infiltrated areas. On average, the pH of the water directly exiting the drain is slightly lower than the stream mean (6.9 v. 7.4).

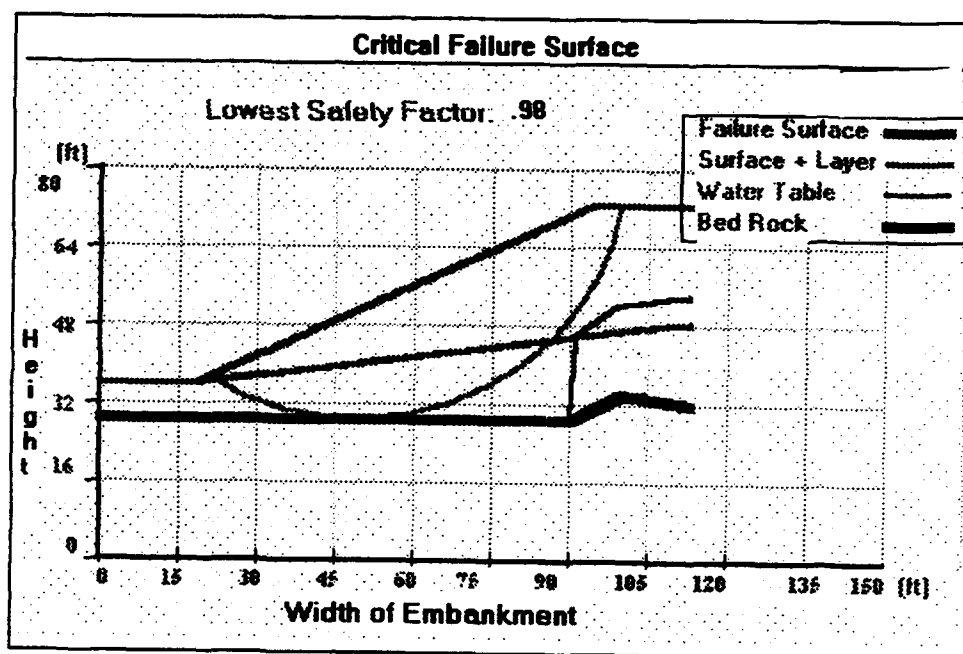
Figure 3.4. SR 541 Embankment, Original Profile, Simulated Drain.

The next scenario involved modifying the existing embankment geometry by adding the effects of an artificial drain. The intent of this exercise was to determine whether the FGD by-product was needed, or whether traditional drain installation would solve the slope stability problem. Figure 3.4 shows the critical failure surface with the input file simulating a drain between the natural soil and the underlying bedrock. There appears to be no difference in the predicted critical failure surface between this scenario and the original condition.

The significant information to be gained from this scenario is that removing the material, installing a drain, and replacing the original material to form the identical embankment would do very little for the long-term stability of the slope. If the friction angle of the natural soil is left as zero, then all of the soil's strength must be due to cohesion, which is unaffected by the lowering of the water table. The calculated factor of safety for this scenario, 0.98, is virtually the same as the factor of safety calculated for the previous scenario, 0.95. The slight difference in the values may be attributable to the program generating incrementally different failure surfaces due to the reconfiguration of the input file. It should be noted that the excavation and reconstruction labor costs associated with stabilizing this embankment are relatively independent of which material is chosen for the reconstruction effort.

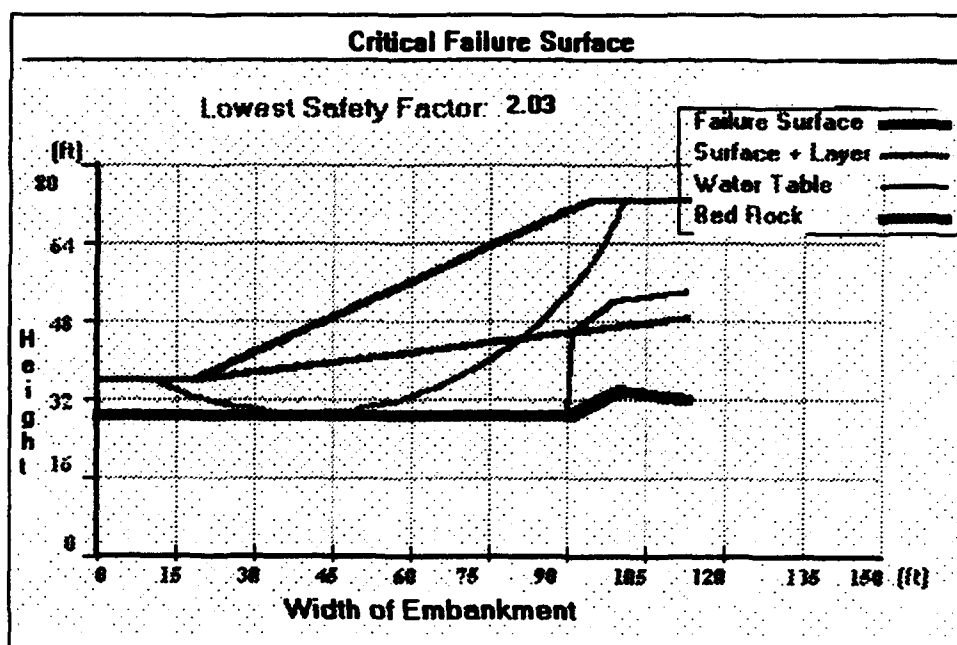
Figure 3.5. SR 541 Embankment, Original Profile, Drained Condition.

In the next scenario studied, the existing soil was excavated and replaced with a select borrow material, and a drain similar to the one outlined in Section 3.3.2.2 was installed. For a fill of the same unit weight and cohesion, but having a friction angle of 20 degrees, a calculated factor of safety of two was obtained. It can be shown that while the select fill doubles the factor of safety for this embankment, the same circular failure surface ultimately develops. See Figure 3.5. Though the calculated factor of safety would be sufficient by most highway design standards, it involves the replacement of approximately 8,000 cubic meters of material, which would have a high cost associated with it. Though a drain is installed in this study,

it is possible that the clay-based select material could become saturated and degrade in strength. The calculated factor of safety would continue to approach one as the strength parameters of the borrow decreased, eventually falling below one and failing. This may be a logical explanation for what actually occurred and why the embankment lasted for approximately 20 years without serious incident.

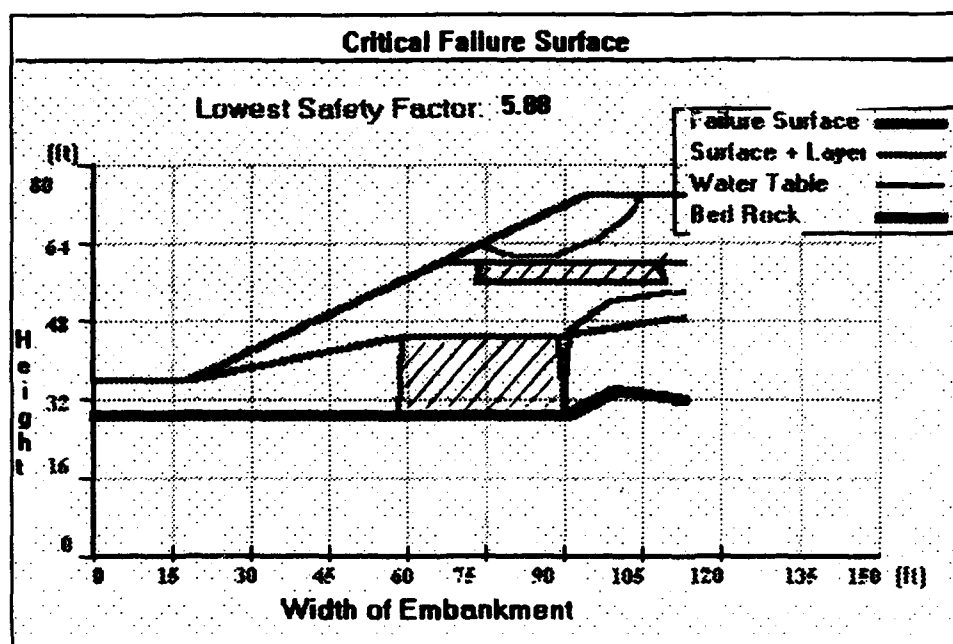
Figure 3.6. SR 541 Embankment, FGD By-Product Reinforcement, Critical Failure.

The next step in the stability analysis of this embankment was to incorporate the clean coal technology by-product layers into the input file. The water table in this calculation was left at its original elevation at the center of the embankment and

was quickly lowered once it made contact with the drainage material adjacent to the lower FGD buttress. What water is not intercepted by the filter is assumed to go around the buttress and exit at either the eastern or western edges of the slope. The program is limited to two-dimensional analysis, therefore the water table was simply lowered to the bottom edge of the buttress and maintained at that elevation. Figure 3.6 depicts the profile of the embankment with the two FGD by-product layers included. The larger buttress is primarily in the natural earth material and sits atop the bedrock. The smaller layer, which is approximately 1 meter thick, lies 6 meters below the surface of the highway.

The friction angle for the natural material was left as zero and the embankment material was assigned its original material properties. The layer atop the second buttress was a combination of crushed shale and select borrow and was given material properties similar to the embankment material. The assigned values proved to be sufficient, as numerous trials showed the shale layer had little effect on the overall embankment stability. The effect of the FGD by-product reinforcement system can best be viewed as Figure 3.7.

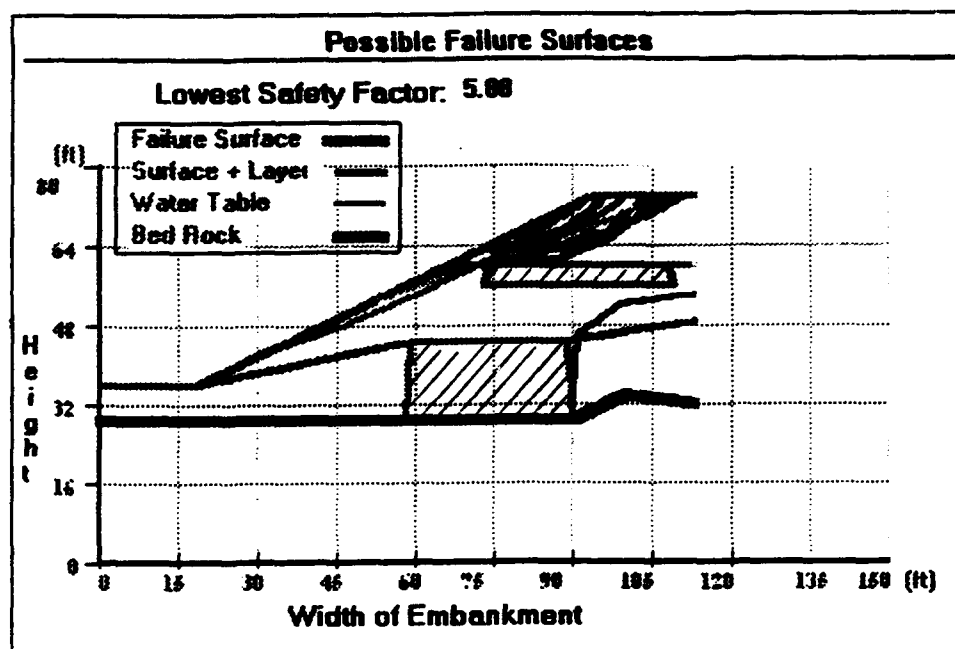
Figure 3.7. SR 541 Embankment, FGD By-Product Reinforcement, All Failure Planes.

The combination of slope stabilizers has forced all likely failure planes out of the FGD by-product and to the surface of the embankment. With the lowest calculated factor of safety of nearly 6, the FGD by-product buttress system has

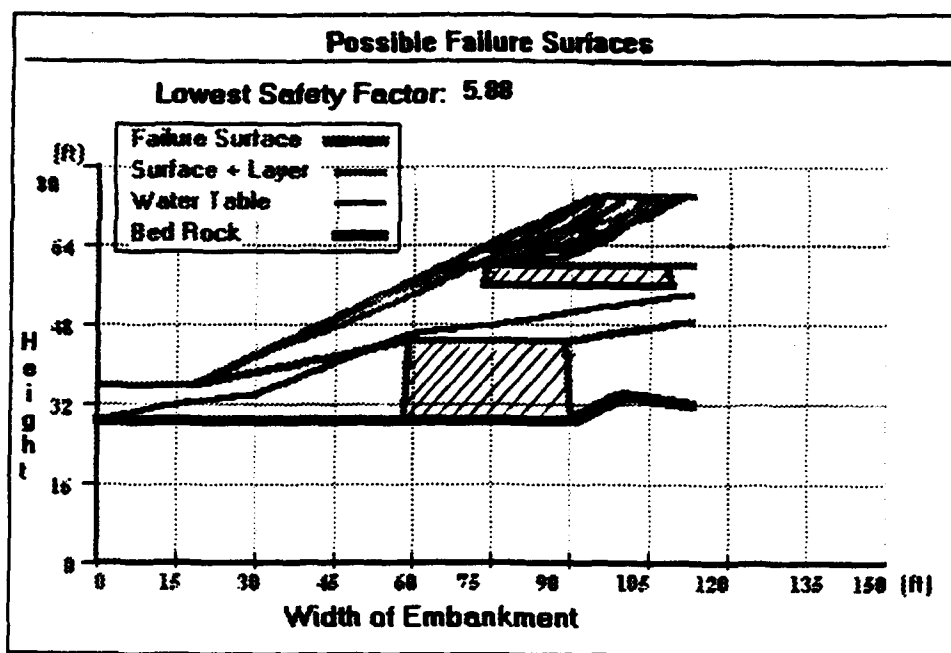
Figure 3.8. SR 541 Embankment, FGD By-Product Reinforcement, Non-Functioning Drain.

This "what if" scenario is presented as Figure 3.8. The most critical failure surfaces are essentially unchanged, as is the critical factor of safety. All of the possible failure surfaces are still shallow and may be classified as surface slips, not moderate to deep rotational slides. This is not surprising, as all of the potential

failure surfaces shown in Figure 3.7 were well above the water table and the inoperative drain should have had no effect. As expected, the overall strength of the FGD material and the relative positioning of the layers greatly reduce the likelihood that this embankment will fail, even under high water table conditions.

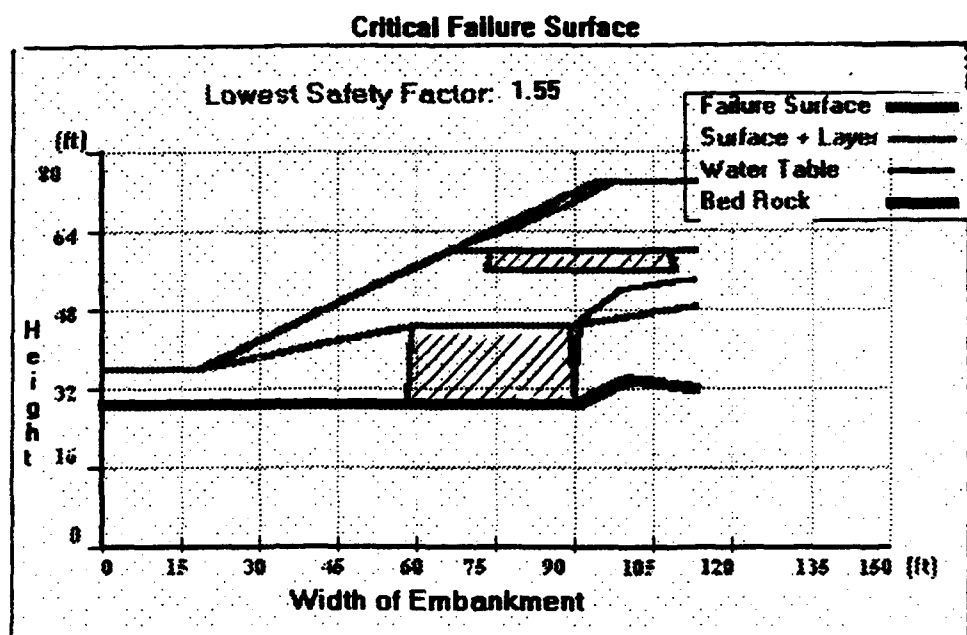
Figure 3.9. SR 541 Embankment, FGD By-Product Reinforcement, Cohesionless Upper Layer.

Assigning a friction angle of thirty-five degrees ($\Phi = 35^\circ$) and giving the material no cohesive value, the calculated factor of safety for the embankment drops to 1.56. The predicted failure surface, depicted as Figure 3.9, is extremely shallow and can be labeled a surface slide. Conversely, if the material at the top of the embankment is given the properties of a moderately stiff clay in an undrained state ($c = 38 \text{ kPa}$, $\Phi = 0^\circ$), then the calculated factor of safety climbs to 4.5. Figure 3.10 depicts this scenario and shows how the predicted failure surfaces are slightly deeper than the ones predicted for the cohesionless material. It may be argued that the shaly-clay that was used atop the thin FGD material layer will soon weather to a clay that would have properties similar to those used to generate Figure 3.10.

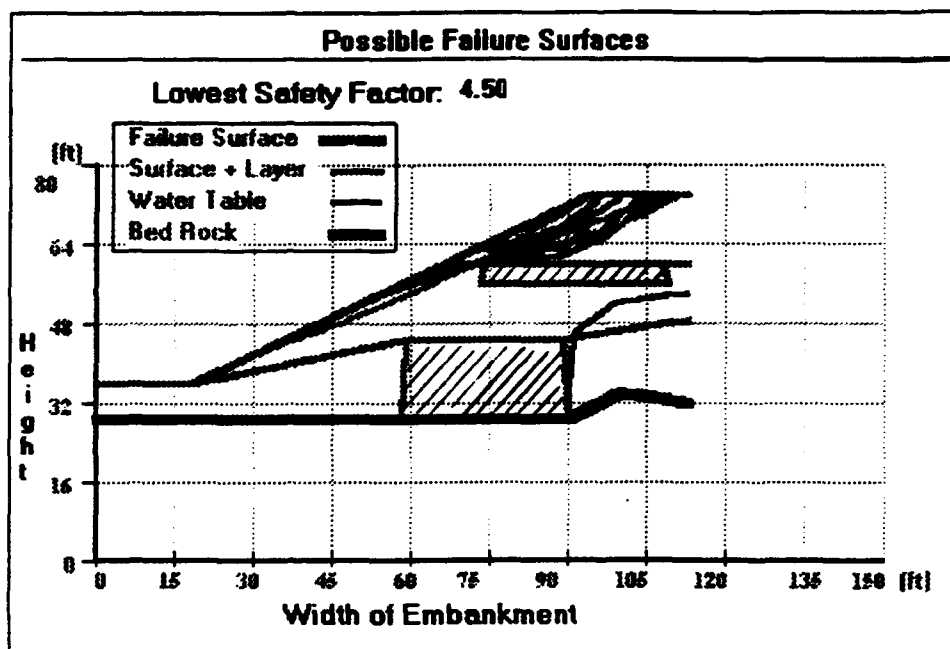
Figure 3.10. SR 541 Embankment, FGD By-Product Reinforcement, Cohesive Upper Layer.

It may further be speculated that the material used to bring the embankment to grade actually had a cohesive value and a friction angle. Since the borrow, which appeared to be a moderate to stiff clay in its intact form, was mixed with the original silty-clay, the composite material could likely have measurable values for both strength parameters. Such a scenario would produce a failure surface and calculated factor of safety similar to the one predicted in Section 3.3.2.4. Exact values were not assigned to this scenario, as the final calculated factor of safety for the entire embankment would be a function of the assumed strength values for the top layer, and not a function of the FGD material in study.

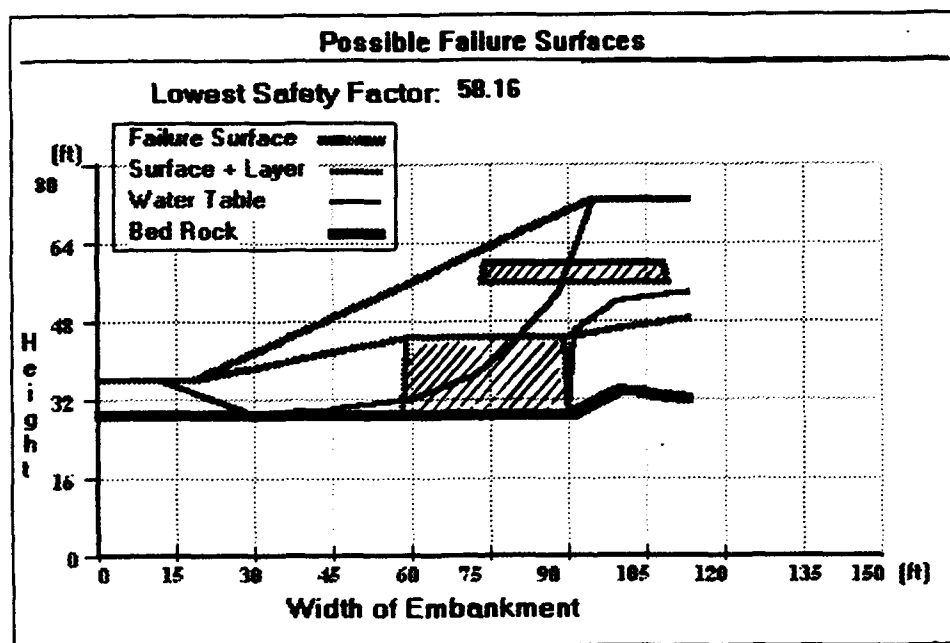
Figure 3.11. SR 541 Embankment, FGD By-Product Reinforcement, Specific Failure Plane.

To further establish the FGD by-products performance as a slope stabilizer, another input file was created that forced the original failure plane to propagate through the modified embankment profile. Using the embankment geometry from 3.3.2.4, a failure surface similar to the one that was observed (Figure 3.3) was specified. This forced the plane to pass through both FGD by-product layers, as seen in Figure 3.11. As expected, the calculated factor of safety for this scenario is extremely high (58) and reinforces the hypothesis that the observed failure geometry will not reoccur.

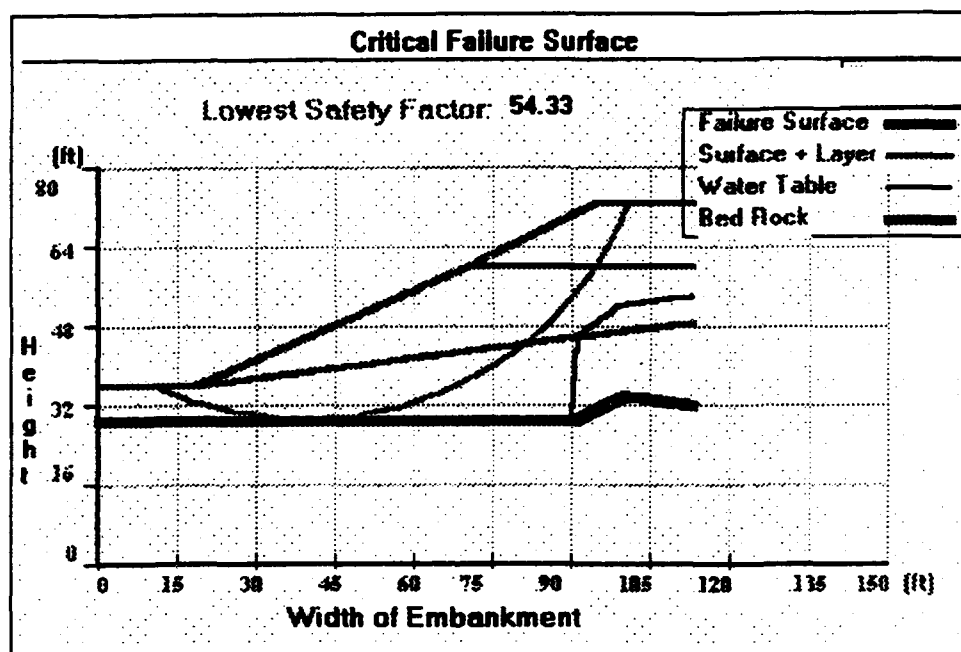
Figure 3.12. SR 541 Embankment, FGD By-Product Reinforcement, Full Depth.

As a final scenario, all of the fill material was given the soil properties of the FGD by-product. Though this may not be prudent, due to drainage problems and transportation costs, it was done to study the potential stability of such an embankment. As can be seen in Figure 3.12, the failure surface returns to the position and geometry that we first saw with the original embankment. The difference is in the enormous calculated factor of safety (54). Though this calculated factor of safety is very high, it is essentially the same as the value calculated for the specified failure plane in the previous sub-section. Therefore, the design key is to locate the most probable failure surface and to construct the by-product layers in a manner that would prevent the critical slip from occurring.
